APPLICATION NOTE

Before and After Images, Hitachi S-4800 on STACIS® iX SEM-Base™ (actual customer supplied data)

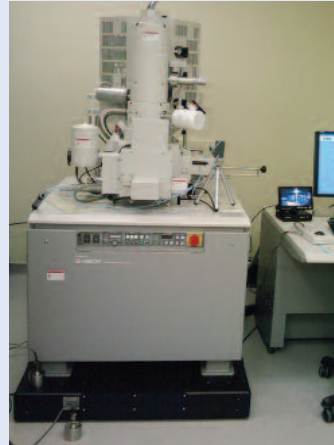
Before

Shown below are “before and after” images obtained by an Hitachi S-4800 Scanning Electron Microscope isolated on a TMC STACIS® iX SEM-Base™ at Nationwide Children’s Hospital in Columbus, Ohio. Images of a pure gold reference sample were taken at 200,000x magnification. In spite of the severe vibration environment (6th floor on a windy day), the SEM-Base™ yielded resolution within specification. These two images were taken immediately before and after the SEM-Base™ installation, respectively. No other variables were changed between photographs.
