**Everstill™ K-400**  
Active Vibration Cancellation Platform

**Everstill™ Technology**  
**Enables safe Micromanipulation**

*Application: Assisted Reproductive Technologies (ART)*  
*Microscope: Olympus IX71*

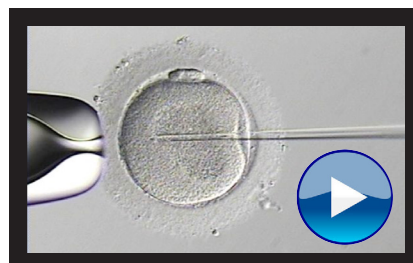
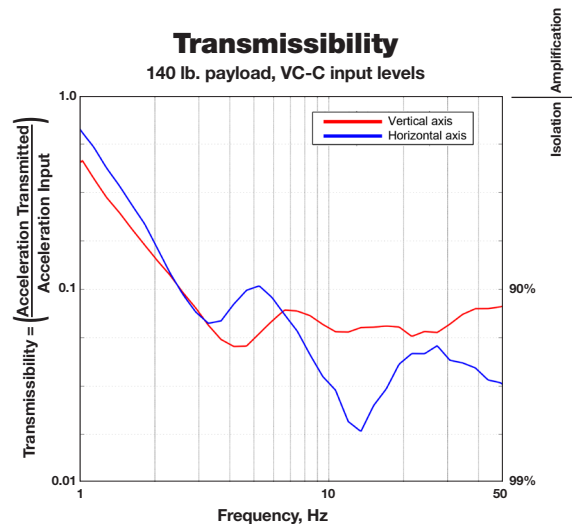
In this attached ICSI video, vibration in the environment is evident in the image of the oocyte. Although low in amplitude, this vibration coming up through the floor and the lab table would prevent a successful procedure. After approximately 35 seconds, the Everstill K-400 is powered on, the vibration is no longer evident, and the procedure continues. With the K-400 installed to support the microscope, the clinic is now able to perform all micromanipulation techniques safely and more efficiently.

The Everstill K-400 provided excellent vibration cancellation allowing for a safe micromanipulation environment. The serial type active vibration control technology provided aggressive low frequency vibration isolation with a stable surface for the microscope. The installation was extremely easy and the unit self-leveled at the push of a button.
